**TECHNICAL BULLETIN**  
**WRIGHT / ANDERSON 120G GRADER**  
**PUMP DRIVESHAFT COVER**

Ref Document No.	TB12005	Issue No.	1
Release Date	November 2012

To advise machine owners of a fitment issue with the hydraulic pump driveshaft cover, that could mean engine pulley comes in contact with cover on full articulation.

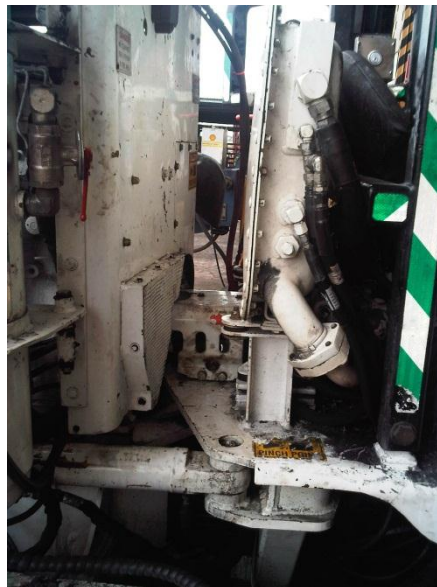
Area of Concern – Driveshaft Cover in Articulation

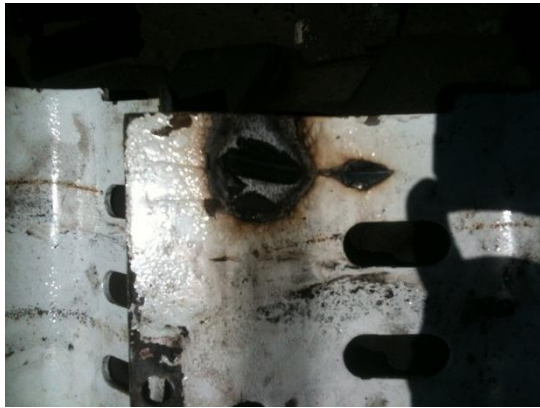
It was noticed by mine site personnel that the driveline cover in the articulation area had sustained damage where it had been in contact with the engine pulley, while the machine had been articulated fully in either direction.

Left half of cover depicting contact area

1. Owners/end users are to inspect these covers and if early style covers are fitted checks must be made to ensure they are fitted correctly.
2. Additional check with vehicles on full articulation in both directions will also confirm correct installation and that engine pulley doesn't hit the covers.
3. Owners / end users that have the early style covers may choose to modify existing covers as per photos to allow for clearance in case of incorrect installation. Refit covers and test on full articulation to confirm clearance.
4. For future manufacture implement additional checks and tests as part of vehicle commissioning

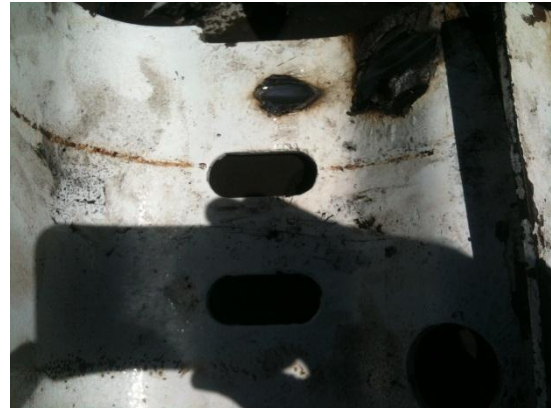
Right Half of Cover depicting contact area

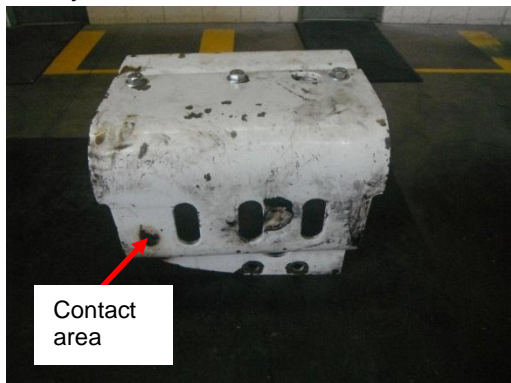
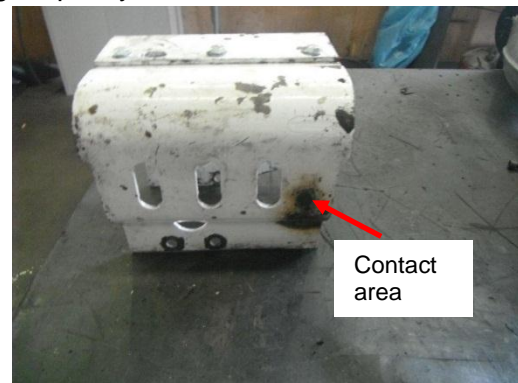
The driveline cover is held in place by two bolts either side of the unit which are symmetrical, allowing the cover to be installed either way. When the early style covers are fitted in the original orientation there is sufficient clearance in both directions when articulated. With the cover in the alternate position, the cover extends over the engine pulley and rubs on the inside while articulating the grader.

Early model design. Note the mounting holes/offset and no cut outs in sides.

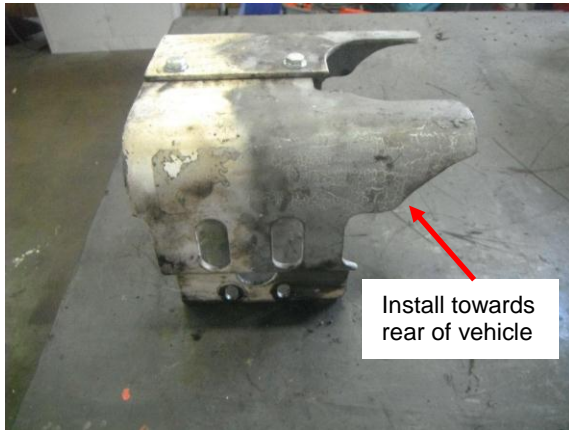
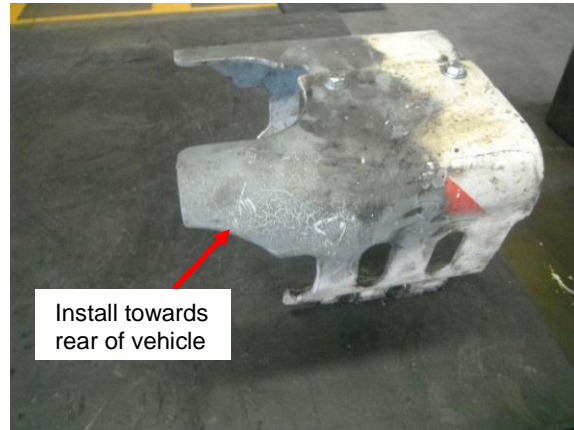
Later model design - These covers should be installed with cut outs to the rear.

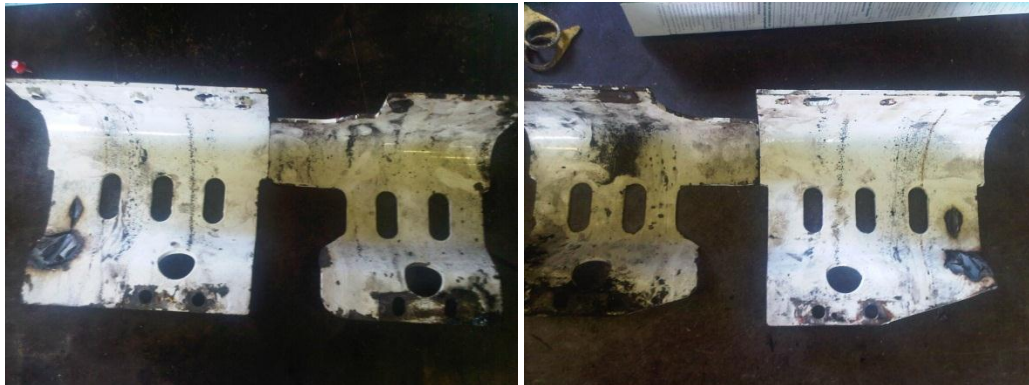
**Note!** Both lower sides of the cover halves need to be cut out as depicted in photos. The additional cut out in the top of the covers is a standard CAT design and not required on underground 120G graders
