TECHNICAL BULLETIN

Ref Document No.	TB15006	Issue No.	1
Subject	Parke Brake Valve Scheduled Replacement		
Release Date	11 th November 2015

Purpose – Advise COALTRAM® owners/operators of the recommended lifecycle for the park brake valve assembly installed in all COALTRAM®.

Applicability – All in service COALTRAM® models CT08, CT10, CT10LP and CT13.

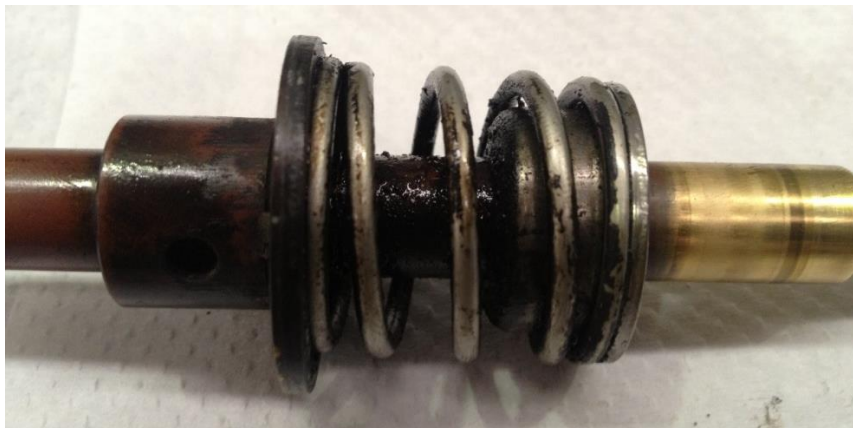
An investigation was completed into the park brake valves failure to return to the applied position when the air pilot was removed. Score marks were found on the valve spool that would allow the spring retaining cup to become stuck on the spool preventing the spool from returning to the closed position. The spring cup is a loose fit over the spool, it was determined that contamination in the return spring housing had initiated the scoring. The images below show the contamination around the spring and the resulting score marks.

Figure 1: Contamination surrounding return spring

3. PPK recommend replacing the park brake valve assembly after 4,000 hours of service. As a critical valve that is not easily overhauled, replacement is recommended. Upon installation any new park brake valves should be stamped with the engine hours for reference. The park brake valve assembly part number is 5520000166.
