TECHNICAL BULLETIN

Ref Document No.	TB13002	Issue No.	1
Subject	Exhaust Gas Test Port		
Release Date	21st October 2013

To advise machine owners of possible leaks from the end of a MSHA approved Exhaust Gas test port.

Applies to all COALTRAM® CT08, CT10 and CT13 vehicles.

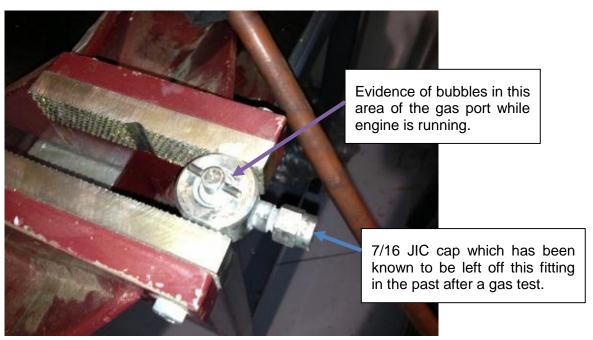
Figure 1: Leaking Valve

A report was made to Diversified Mining Services (DMS) noting that a local mine has identified a leak in the end of a MSHA approved Exhaust Gas test port valve.

The sampled valve was taken by DMS for closer analysis to identify where and how the leak occurred.

Due to the identified issue with the gas port being removed for gas testing as not enough exhaust gas can be withdrawn between the clearances of the open joint and the non-compliance to meet the AS/NZS 3584.2:2008 it is the OEM's decision to inform the industry that the gas port shall be removed from every vehicle fitted with the unit. A standard 1/8" BSPT to 7/16" JIC male to male nipple with 7/16" JIC Cap is to be fitted in its place.

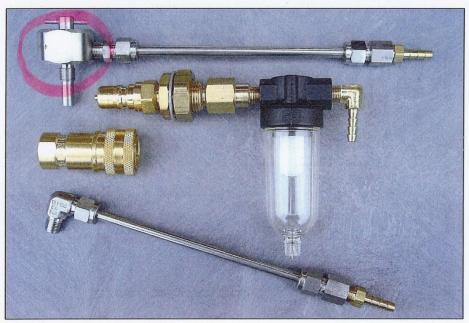
EXHAUST GAS SAMPLING PORT KITS

Flame-Proof Port

A Flame-proof Port is permanently installed in both the total intake restriction and total exhaust backpressure port. The design of the Flame-proof Port meets all MSHA requirements for flame proof components, and has been tested and certified by MSHA as part of flame-proof intake and exhaust systems. Tests can now be conveniently performed at either an inby or outby location of the mine.

A pipe or hose connection is provided from each Flame-proof Port to the operator's cab, where either a permanently installed gauge or a quick connect gauge may be used to perform the MSHA required measurements. In either case, the mechanic can perform the tests from inside the safe location of the operator's cab.

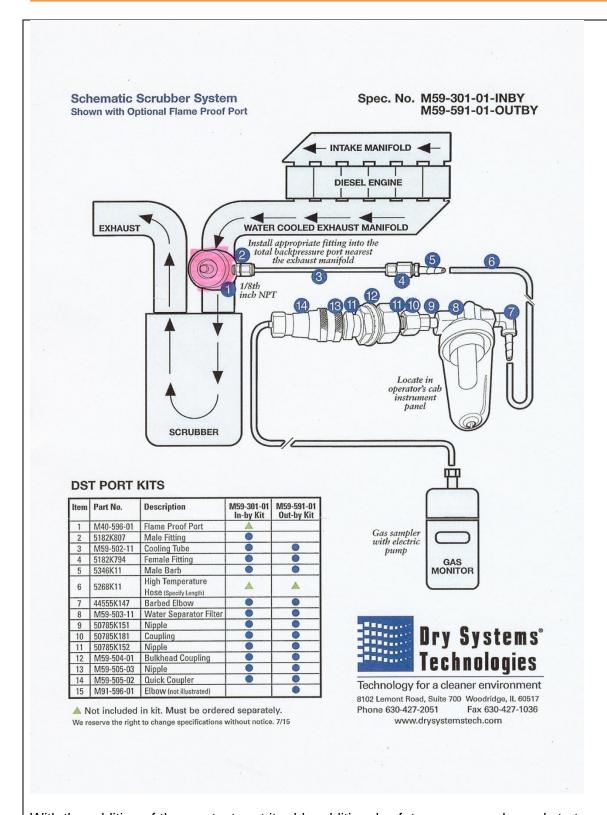
Figure 2: Test Point Internals

With the addition of the gas test port it adds additional safety as any spark needs to travel along the open joint and has an increased capacity to cool the spark before it enters external atmosphere along the shaft area as seen in Figure 2 below.

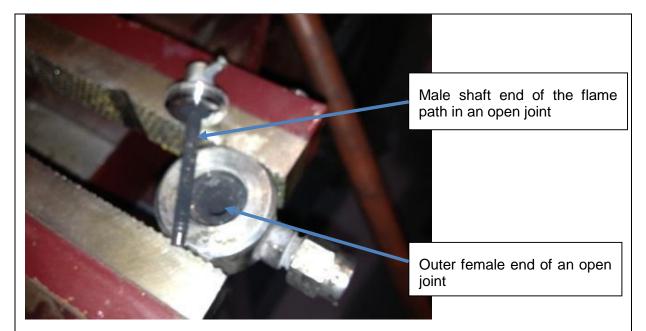
A review of clearance was undertaken to compare the test point with AS/NZS 3584.2: 2008. It was identified that by only having a flame path length of 42 mm the clearance between the spindle and the outer bore according to the standard should have been 0.43mm while the actual measurement was measured at 0.70 mm.

There was also some evidence that the clearances between the inner and the outer parts of the gas test port (the open joint) did not allow enough gas flow to take bag samples while doing a gas test and therefore the whole assembly was being removed, defeating the purpose of the design.
